WHITE PAPER

Reducing Bypass Airflow Is Essential for Eliminating Computer Room Hotspots

By Robert F. Sullivan, Ph.D, with Lars Strong P.E., and Kenneth G. Brill

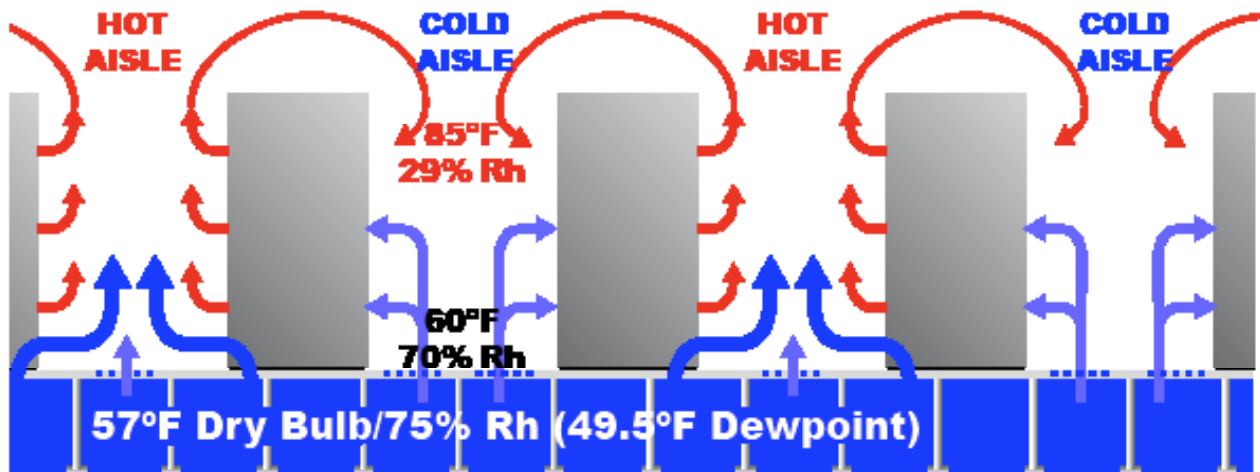
Figure 1—Recirculation of hot exhaust air across the top of racks due to an inadequate supply of cold air from perforated tiles will result in unacceptably high intake air temperatures for the equipment housed in the top of racks. (The majority of the hot racks reported in this paper were hot only at the top of the rack.)

Vertical hotspots occur because the internal fans within the computer equipment at the bottom of a rack or cabinet have consumed the available supply of cold air coming from nearby perforated tiles. With no cool air remaining, equipment above the temperature transition is left to pull air from the hot exhausts of adjacent computer equipment or from the ambient conditions in the room.

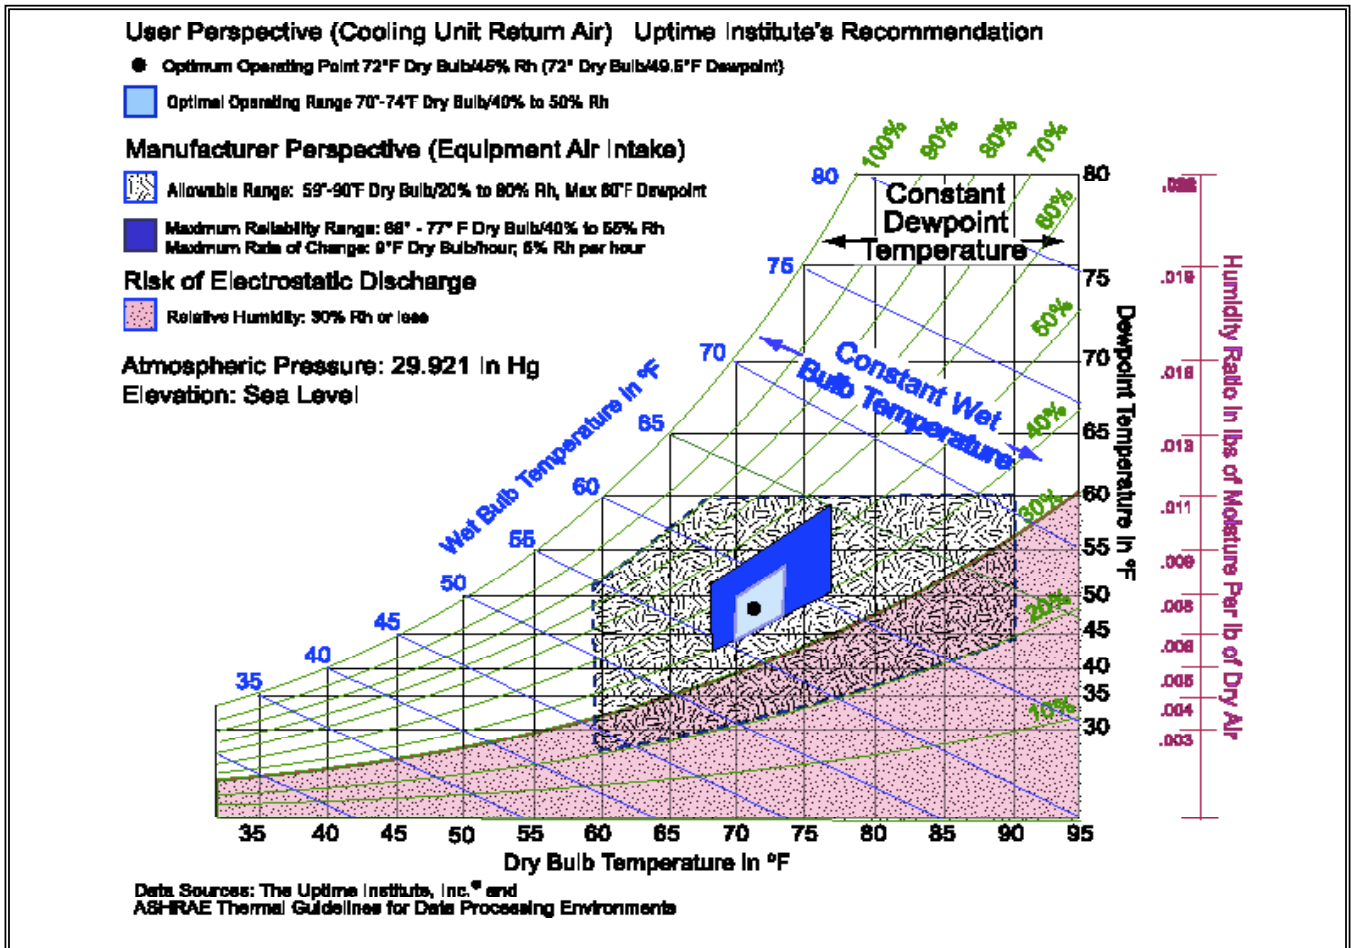
Figure 2—Computer Hardware Reliability Environmental Reliability Limits

recommendations are shown in Figure 2 along with the Institute’s recommended cooling unit return air control set-point.

A number of very important points can be drawn from Figure 2:

- Environmental conditions are determined at the air intake of the equipment. The discharge temperature of the hardware exhaust air, or the air measured 48” (1.2 m) above the floor, or back at the cooling unit is of little concern. What counts, in terms of reliability, performance, and warranty, are the conditions at the equipment air intake.

- While the equipment may operate at air intake temperatures of up to 90°F (32.2°C) or at a relative humidity within 35% to 80% (depending upon dry bulb), it may not run reliably or at specified performance standards.

- For maximum performance and reliability, computer manufacturers recommend a maximum temperature of less than 77°F (25°C) with a rate of change not exceeding 9°F (5°C) per hour.

- For maximum reliability and performance, relative humidity (Rh) must exceed 40% with a rate of change not to exceed 5% per hour. The threat of spontaneous electrostatic discharge begins to occur when Rh is 30% or less.

- Users can’t control rack intake air temperatures which may be 50 feet (15m) away from cooling units. What they can control is the return air temperature and relative humidity back at cooling units.
- The divergence between computer manufacturer air intake requirements and what users can control and deliver is a major industry problem.
- The Institute’s recommended return air control point at the cooling unit is 72°F/45% Rh (22.2°C/45% Rh). This allows for optimal cooling unit efficiency with some tolerance for local hotspots.

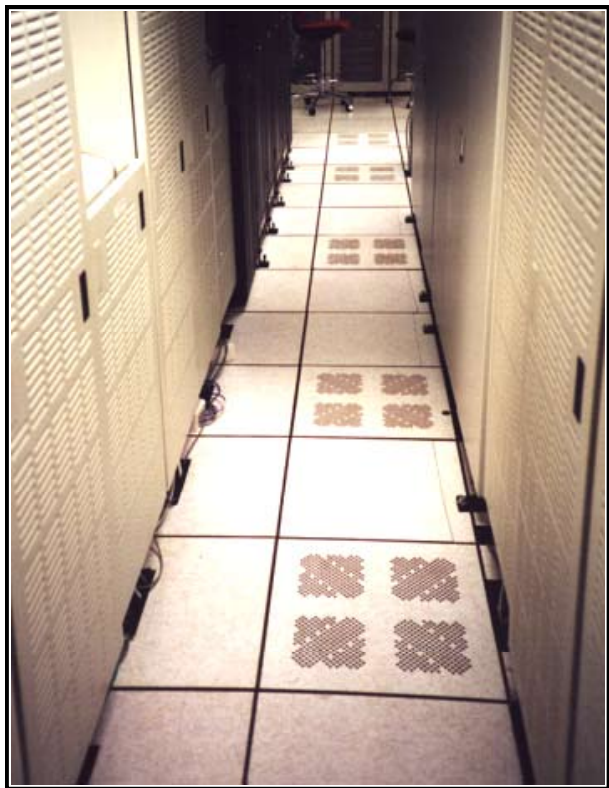
Figure 3. These misplaced perforated tiles and less obvious unmanaged cable openings are allowing valuable cold air to escape. Forty-five percent of the capacity of a 20-ton cooling unit is being wasted in this picture.

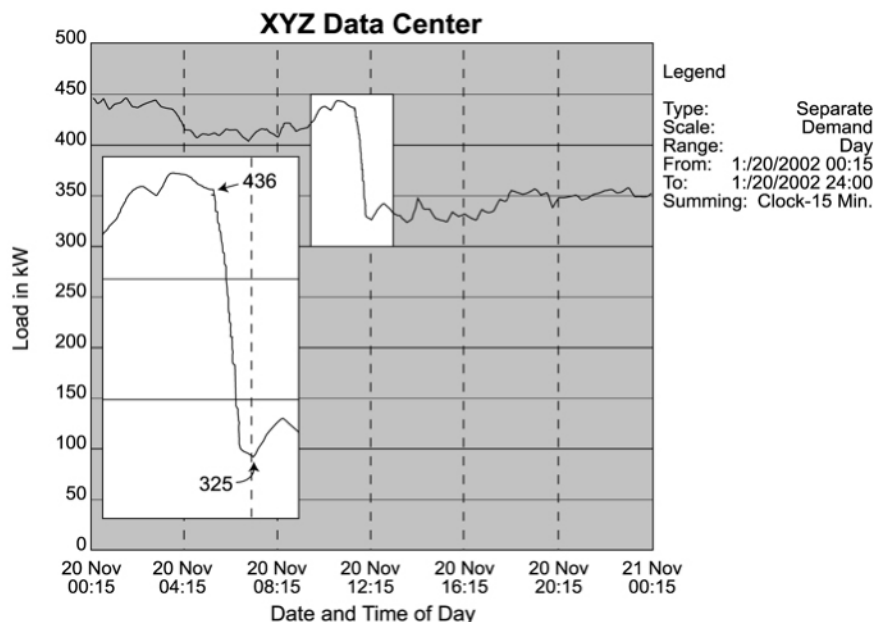
Figure 4—A worried utility manager faxed this electricity consumption graph to his data center customer, noting an abrupt drop in energy consumption. The 111 kW per hour reduction far exceeded the kW saved from turning off 11 cooling units or approximately 55 fan horsepower. This indicates the reduction in de-humidification and re-humidification was a very significant factor in saving energy.

Energy consumption for the 11 cooling unit fans turned off (another 7 to 9 units could have been turned off if bypass airflow had been reduced from 71% to 10%) would have been about 41kW, yet total energy consumption went down by 111 kW per hour (or an annual savings of almost 1,000,000 kWh). The only explanation for the additional 70 kW reduction was energy consumed by dehumidification, re-humidification, and re-heat was eliminated as all other load and environmental conditions remained unchanged.
